**POLYPROPYLENE  
FIBER-REINFORCED  
MICROSILICA CONCRETE  
BRIDGE DECK OVERLAY  
AT LINK RIVER BRIDGE**

**Final Report**

**Experimental Features Project 98-01**

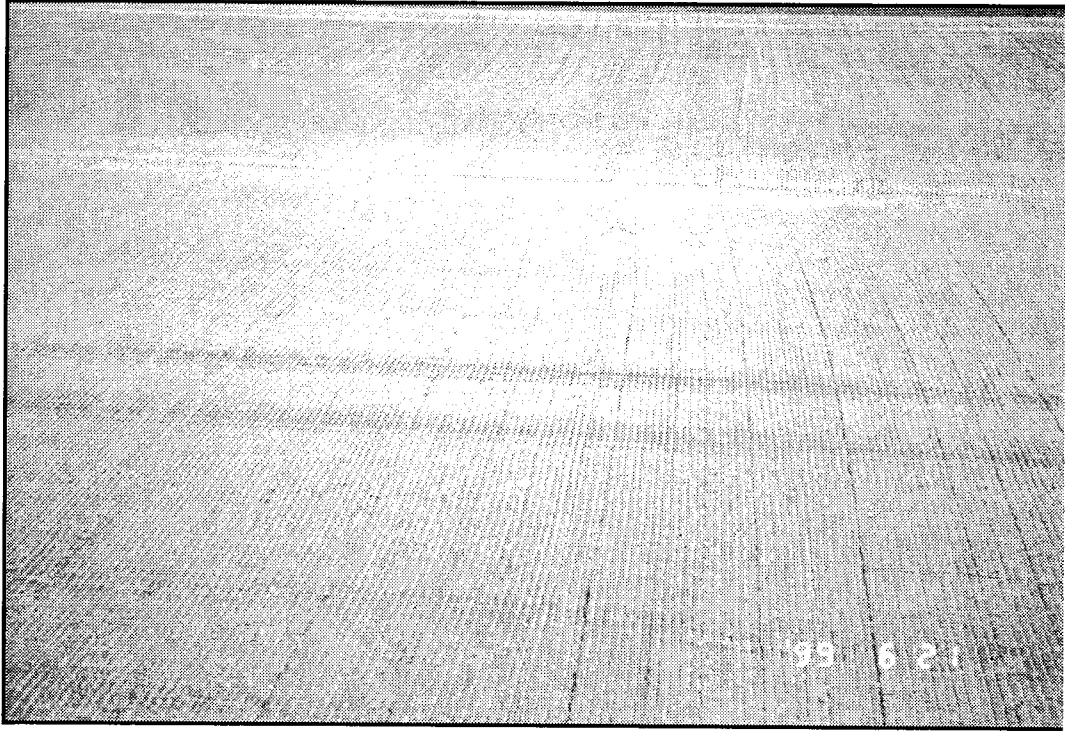
The deck was inspected about two years after the deck pour. Cracking was found in both lanes, with the majority in the northbound lanes constructed with the FMC. Figure 4.1 shows the typical cracking found in the northbound lane, while figure 4.2 shows the typical crack-free southbound lane.

Figure 4.1: Typical cracking in northbound lane two years after construction.

Cracking resistance was found to be no better in the northbound lane with fibers, compared to the southbound lane without fibers. Cracking was also observed in both lanes two years after construction. Thus the vendor's claim of reducing cracking on both the short term and long term was not supported.

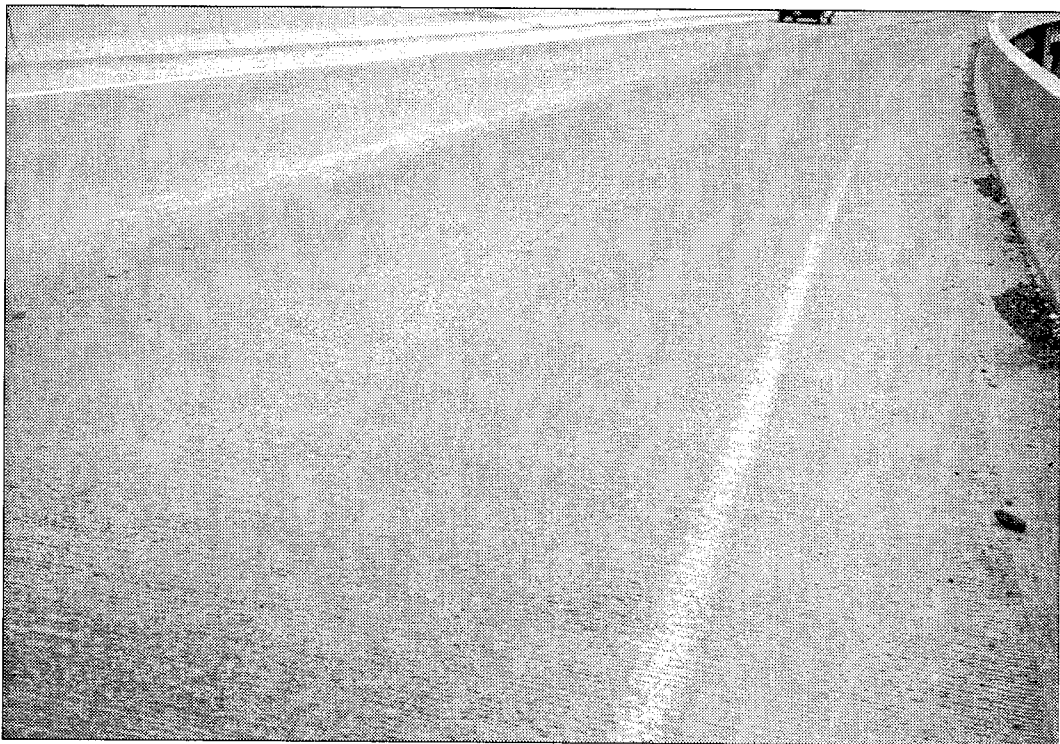
Figure 4.2: No large cracks were found in the southbound lane.
